Smithsonian American Art Museum

Treatment Report

Artist: John Folinsbee (1892-1972)

Description/Title: *By the Upper Lock*

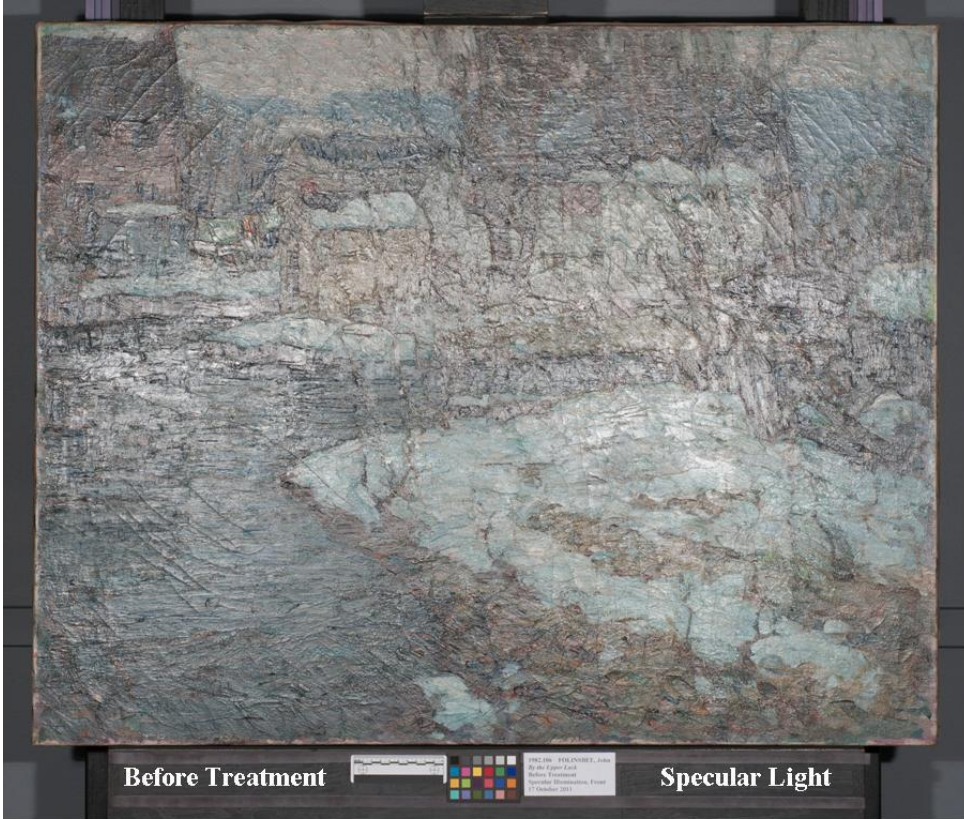
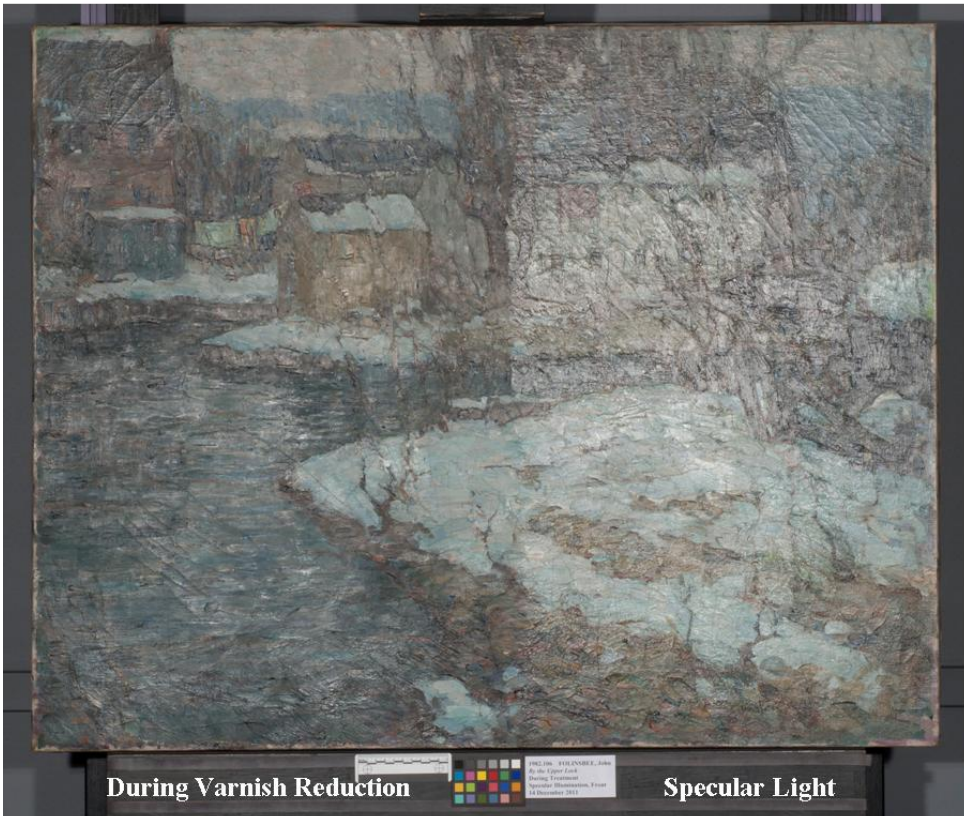
Surface cleaning with 1.5% EDTA in deionized water at a pH of 6.5 (and clearing with water modified to the same pH)

- 3) The paint surface was cleaned using an ethylenediaminetetraacetic acid (EDTA) solution (approximately 1.5% w/v) in deionized water buffered to pH 6.5. A 200mL solution was made using the Modular Cleaning Program. The recipe included 2.1 grams of Bis-tris, 2.9 grams of EDTA, 4.8mL of 10% (v/v) hydrochloric acid, 10.7mL of 10% (w/v) sodium hydroxide, and additional acid or base to bring the solution to the appropriate pH. The cleaning solution was cleared using deionized water adjusted to pH 6.5 (with glacial acetic acid and ammonium hydroxide). Both the cleaning and clearing solutions were applied using cotton swabs.

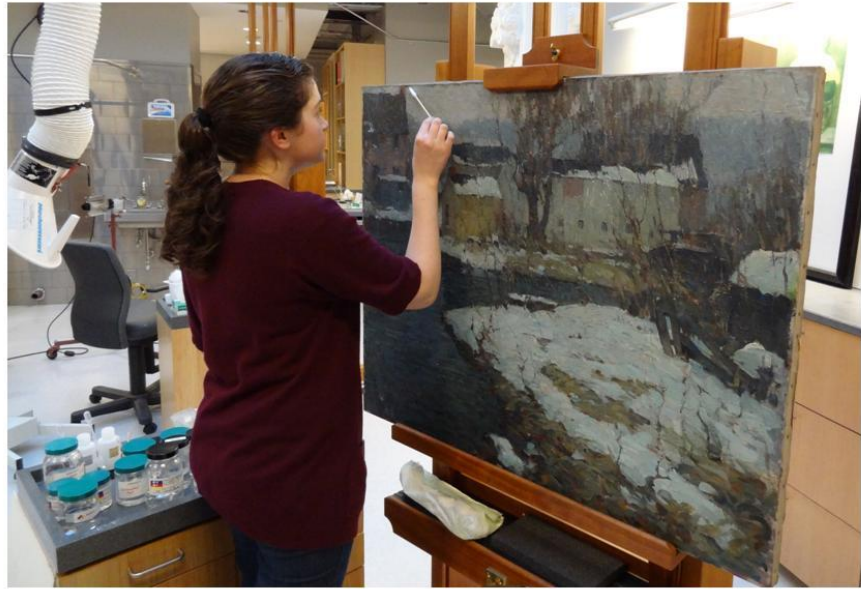
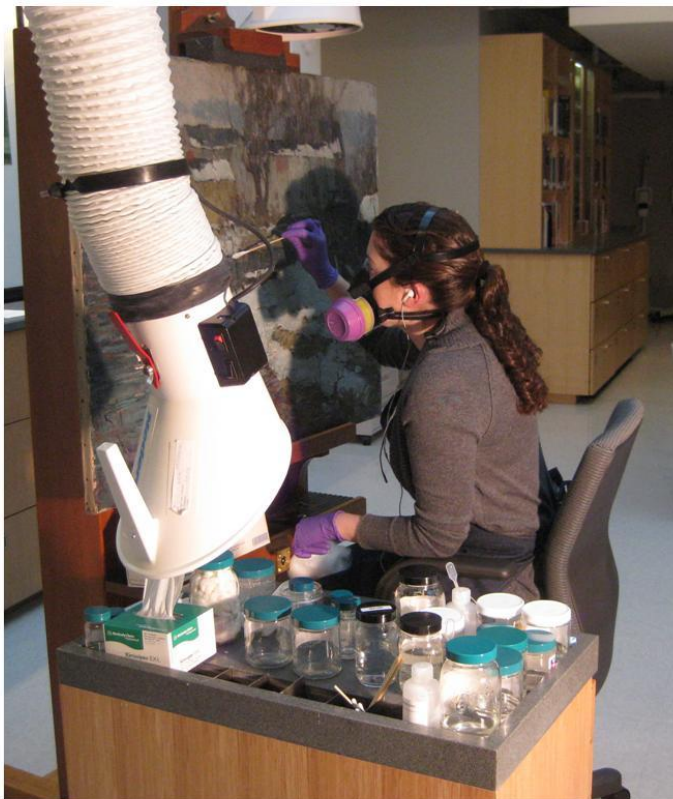
Reducing the varnish using a solvent gel of 1:1 xylene and petroleum benzine (and clearing with those solvents in a 1:1 mixture or, for sensitive areas, just petroleum benzine)

- 4) The Soluvar Gloss varnish (documented as used in the 1984 treatment by Q.R.) was reduced using predominantly a 1:1 xylene to petroleum benzine gel. The ingredients of the gel were 100mL of solvent, 2g of Carbopol 934, 20mL of Ethomeen C-12, and approximately 1mL of deionized water. During the varnish reduction process, some areas of paint appeared to be slightly sensitive to anything but petroleum benzine. This is possibly due to the use of Vulpex (an alkaline soap) used in the 1984 treatment. When reducing the varnish with the gel, if an area appeared sensitive, the gel was cleared using petroleum benzine. Otherwise, the gel was cleared using 1:1 xylene to petroleum benzine solvent. Finally, for varnish areas that were more difficult to reduce, toluene solvent was found to be more effective than the gel. Overall, the Soluvar Gloss restoration varnish appeared to solubilize unevenly, resulting in paint areas that are more matte than others; however, some of the variation in gloss also appears to be due to the artist's paints.

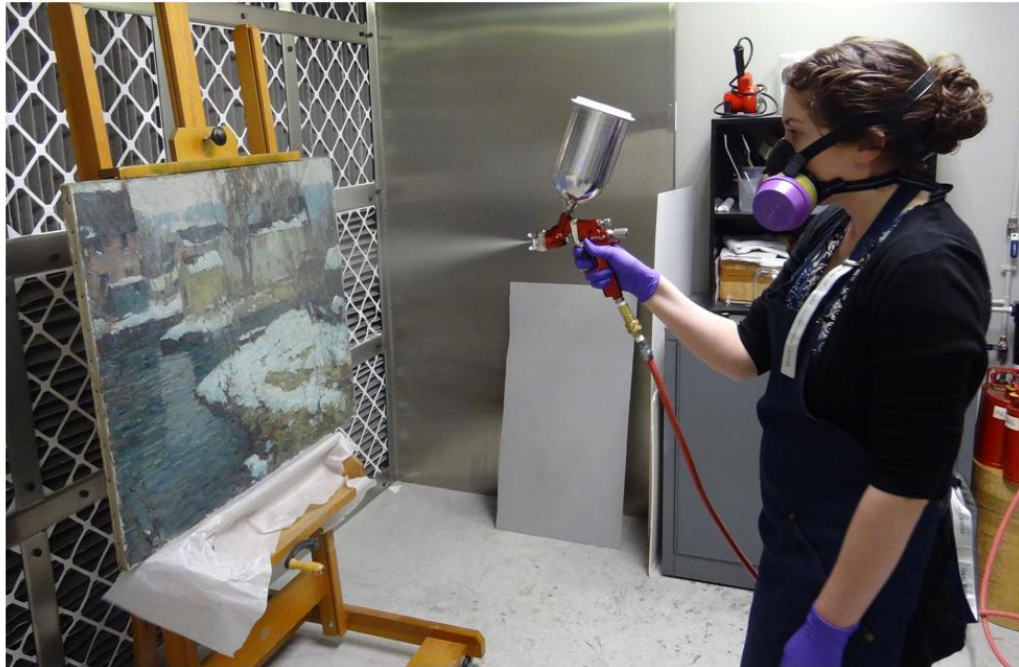
Varnishing with 5% Regalrez 1094 in ShellSol D38

- 7) The painting was varnished with 5% (w/w) Regalrez 1094 in ShellSol D38, which provided a more homogeneous matte surface.¹ The decision to varnish the painting was made because of the variation in surface gloss after varnish reduction. Current research has been inconclusive as to whether Folinsbee applied varnish to his works or not. According to the conservation file documents for this painting, the previous conservator removed a varnish layer before applying Soluvar Gloss; however it is not known whether this initial varnish was original or restoration. To learn more about the artist's technique, the Folinsbee paintings of the Corcoran Gallery of Art and the Phillips Collection were examined and compared to *By the Upper Lock*. Both *Grey Thaw* (of the Corcoran) from 1920 and *Along the Canal* (of the Phillips) from 1921 have a varnish layer. *Grey Thaw* was treated shortly after the painting entered the Corcoran collection, but there is no record of the treatment, and the varnish could be a restoration layer; however, the varnish of *Along the Canal* is very thin and could be original, as the painting does not appear to have been treated.

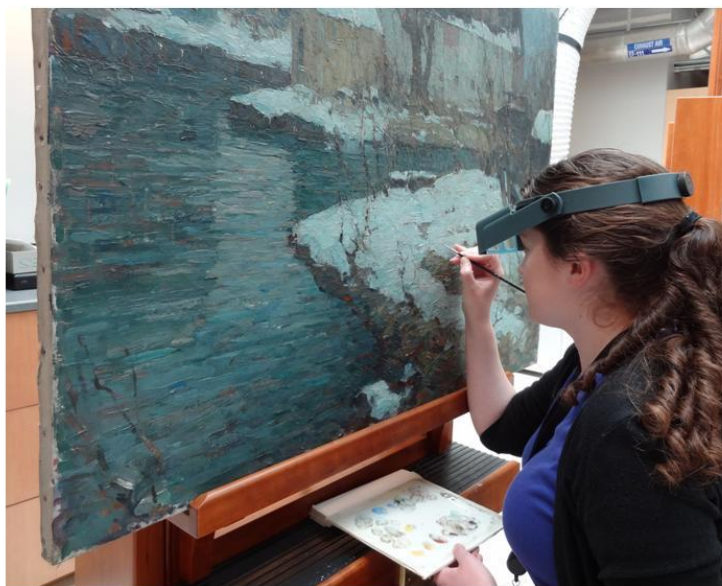
Inpainting with
Golden PVA
Conservation
Paints and
Paraloid B72
Retouching Gels

- 8) Visually distracting paint cracks were inpainted using Golden PVA Conservation Paints (1:1 AYAA and AYAC polyvinyl acetate resins, diluted using 9:1 isopropanol to diacetone alcohol) and Paraloid B72 Retouching Gels (ethyl methacrylate/methyl acrylate copolymer with hindered amine light stabilizers in either 1-propoxy-2-propanol or 1-methoxy-2-propanol). Surface abrasions required a more matte inpainting medium, and so Golden MSA Conservation Colors (pigments in a Mineral Spirit-borne Acrylic resin system diluted with 4:1 diacetone alcohol to xylene) were used.

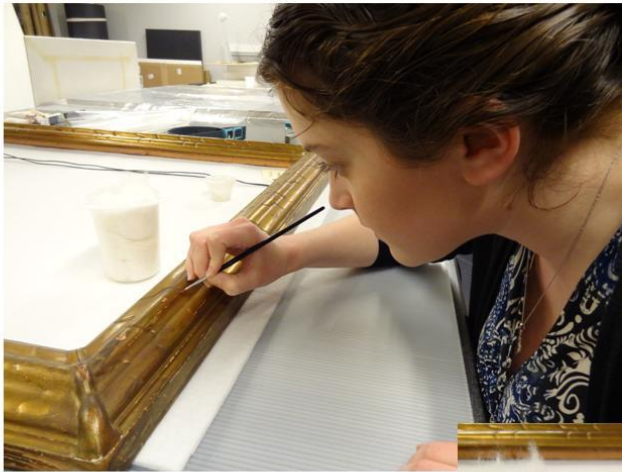
Consolidating flaking design layers using thin rabbit skin glue

Brush applying the glue and then setting down the design layers using a rubber-tipped tool

- 1) Flaking design layers of the frame were consolidated using thin rabbit skin glue (1 ounce of glue to 8 ounces of water).
- 2) Frame losses were filled with traditional gesso (toned with red and yellow ochre pigments).
- 3) Distracting restoration paints (including bronze paint) were reduced using solvents, including acetone, 1:1 acetone and petroleum benzine, and ethanol.
- 4) The compo loss at the upper proper left corner of the frame was rebuilt with gesso. The gesso was applied in layers and then smoothed using cotton swabs dampened with

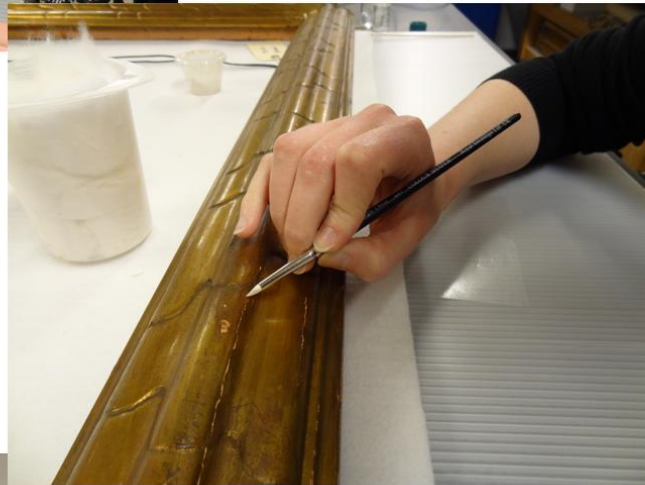
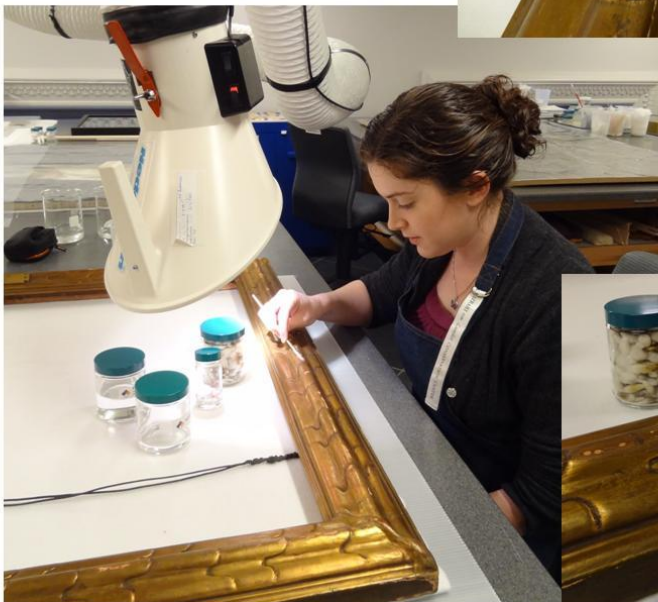
Reducing bronze and restoration paints using neat acetone, ethanol, and petroleum benzine

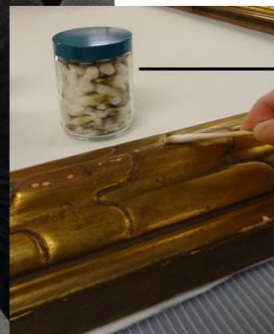
Swabs with overpaint

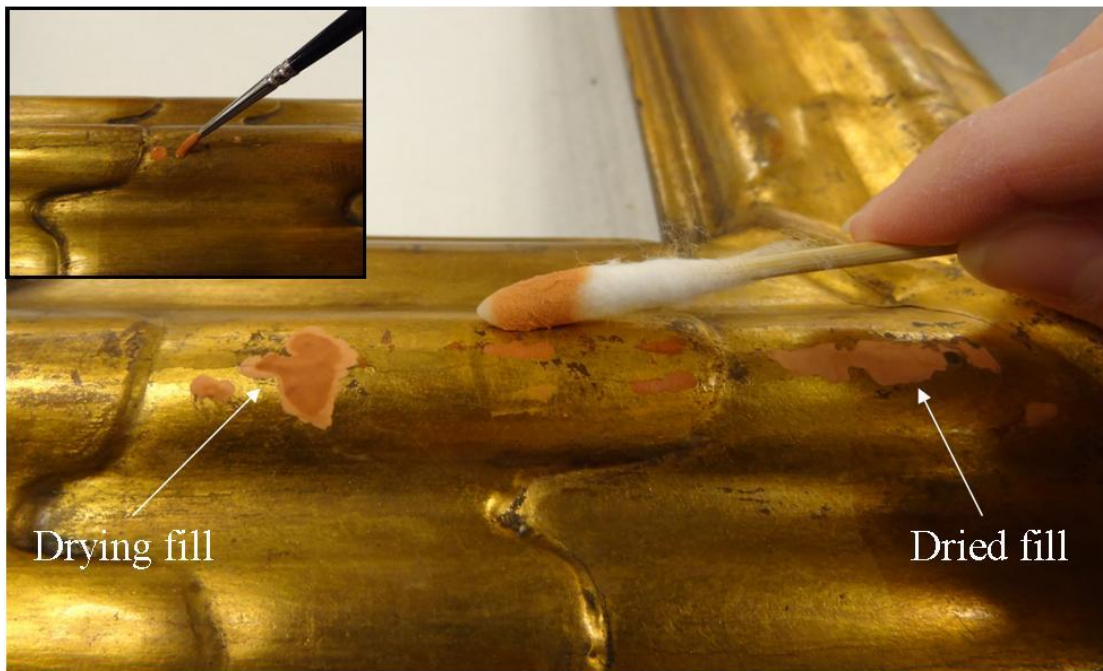
Filling losses with toned gesso (inset) and smoothing the fills with a dampened swab

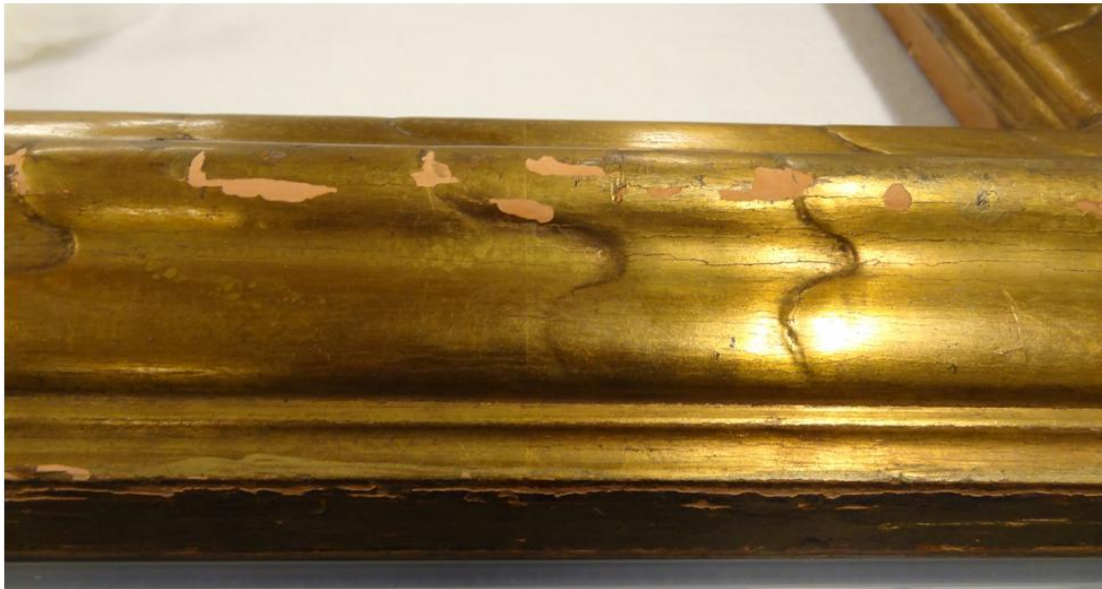
Smooth and dry fills

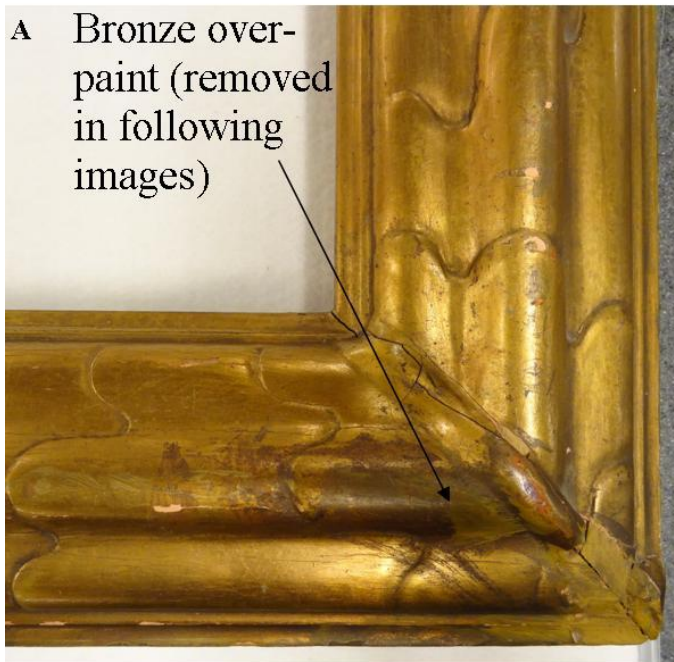
A: The upper proper left corner with a significant loss in the design compo

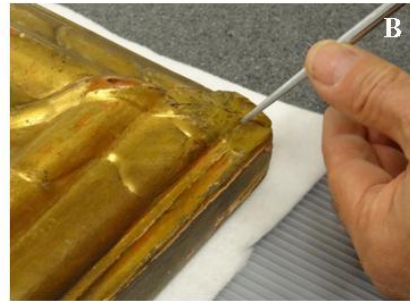
B: Martin Kotler, Frames Conservator, demonstrating how to create tothing holes in the wood to hold the gesso fill

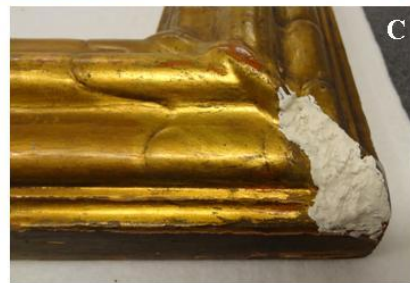
C: A coat of gesso for the corner fill, allowed to dry prior to the application of the next gesso layer

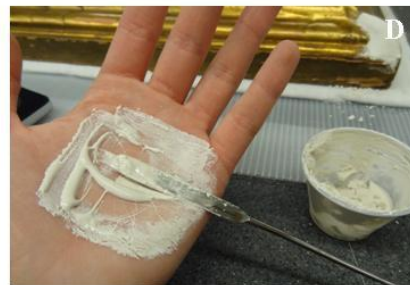
D: Hand-warming the gesso in preparation for the next layer

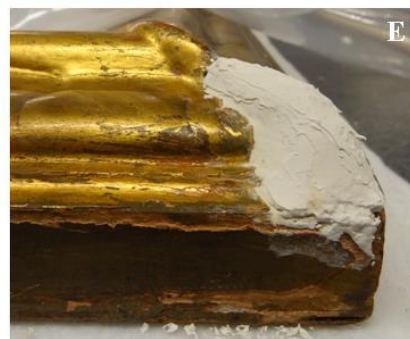
E: The layered fill, built to the approximate shape

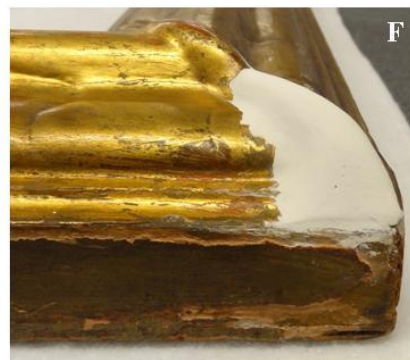
F: The fill after smoothing the surface with dampened swabs
